**RESULTS OF PHYTOTOXICOLOGY SURVEY
FORMER SANDERSON-HEARLD PROPERTY
PARIS (1995)**

JUNE 1996

**Ministry of
Environment
and Energy**

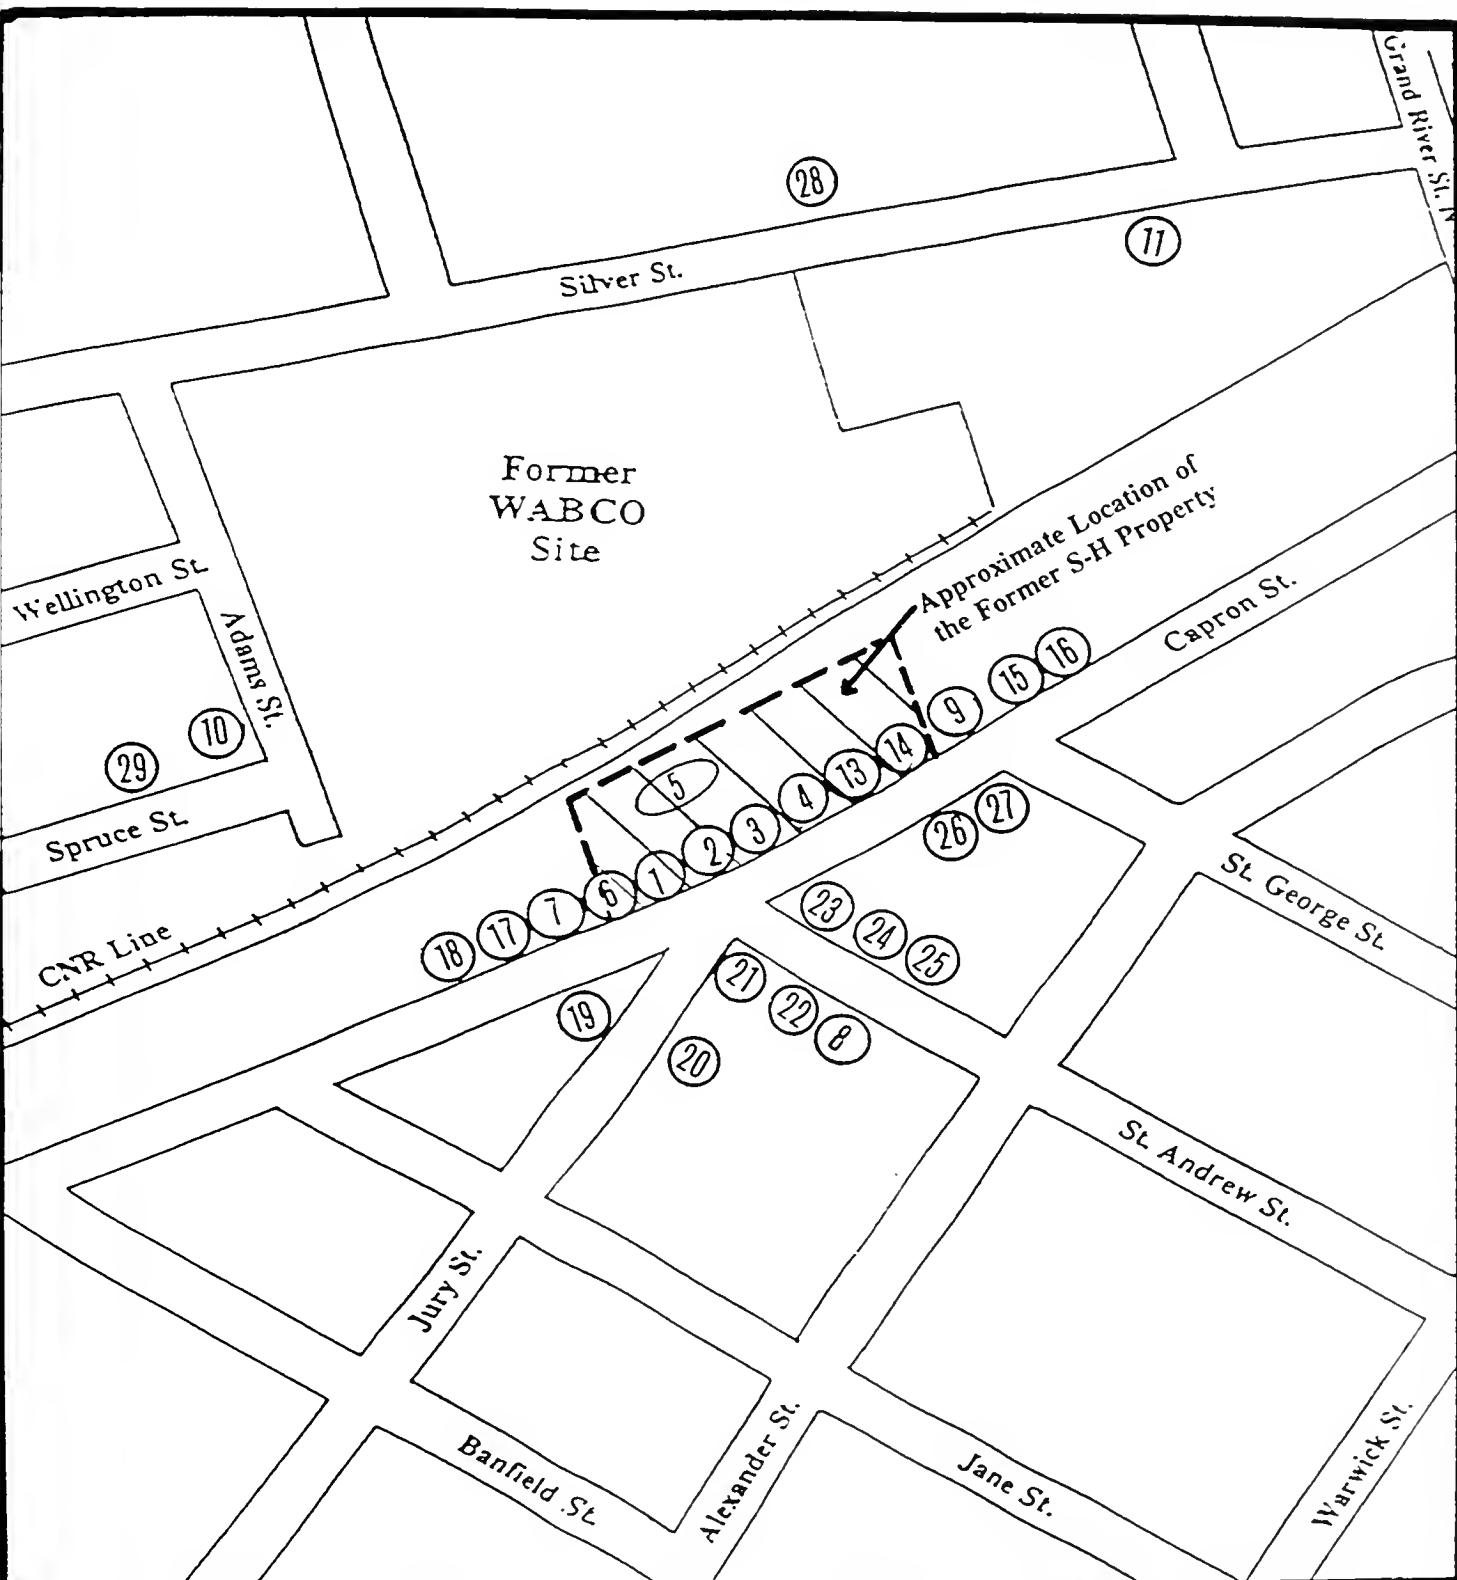
Properties/Sites Sampled in the Area of the Former S-H Property, Paris - 1994 and 1995

Surface soil was collected from the front lawns, back lawns and vegetable gardens that were not sampled in 1994 on the residential properties with identifier numbers 1, 2, 3, 4, 6, 7, 8 and 9 (see attached map). All of these properties were situated in the general S-H area. The three residential sites that exceeded the ULN (500 µg/g) in 1994 - the back lawn and garden at Property 2, and the back lawn at Property 4 - were resampled to verify the earlier lead levels in the soil. Additional residential properties (front lawns, back lawns, vegetable gardens) not previously sampled in the general S-H area (Sites 13 through 27) were also sampled. A front lawn at Property 28 downwind of the former industrial Wabco property and a distant control property (30) off Jane St. completed the 1995 sampling.
